Expansion Joints for HRSG Stack Inlet

Application Brief

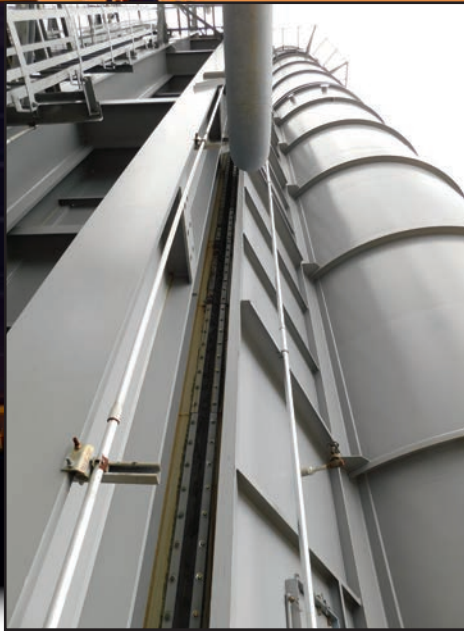
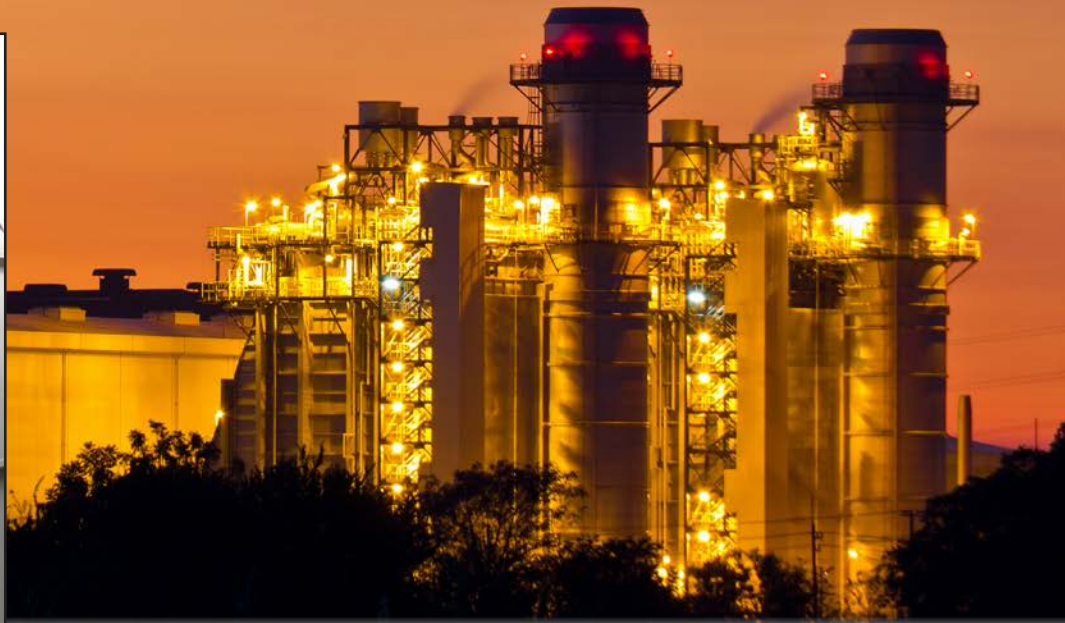
The exhaust stack is connected to the outlet of the HRSG with uninsulated ducting and an expansion joint. Despite the low temperatures (under 350°F-400°F) and minimal movements, the expansion joint installed at the stack requires careful material selection, design construction, and installation to ensure reliable operation.

- Assembled on-site and constructed of a thin-layered fabric belt
- Susceptible to corrosion due to dew point environment, requiring an acid resistant material
- Gasket and bolting hardware selections are critical to a long service life
- Experienced service teams provide turnkey installation from scaffolding or boom lift

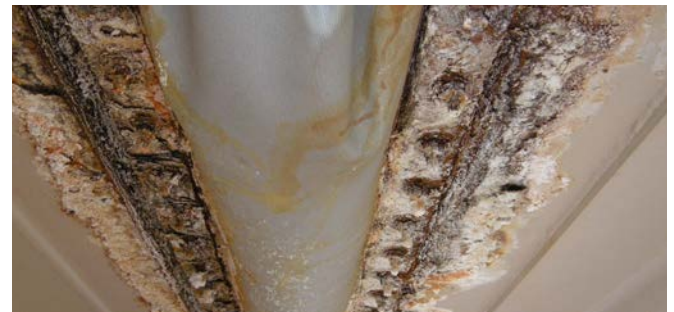
Failed stack inlet expansion joint due to corrosion

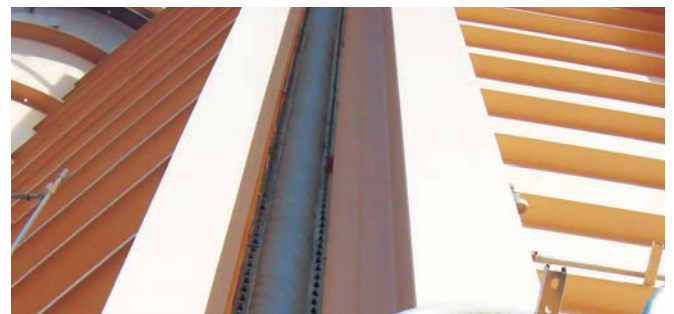
Fabric material selection is key to ensure the expansion joint can withstand the corrosive environment
